Real-World Explosions and Fire Examples

by Dr. John Nordin

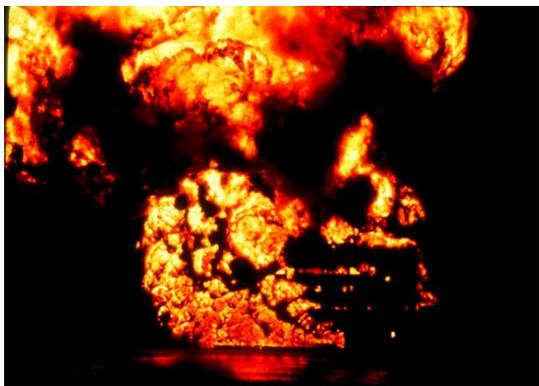
Houston (Pasadena) Texas 1989 Petrochemical Vapor Cloud Explosion and Fire, 23 Fatalities

On 23 October 1989, at about 1 PM, a vapor cloud explosion and fireball occurred at the Phillips 66 Company polyethylene production plant near Pasadena, Texas, killing 23 workers, one worker missing, and injuring more than 130 others (one account said 314 people injured). The accident was investigated by Occupational Safety and Health Administration, the Environmental Protection Agency and other agencies; the OSHA report is available at <http://ncsp.tamu.edu/reports/phillips/first%20part.pdf> and a book on the incident is available through <http://catalogue.nla.gov.au/Record/4183313?&#details>.

The vapor cloud resulted as a sudden gas release of an estimated 85,000 lbs of a flammable gas mixture through an 8-inch open valve; the gas was a mixture of hydrogen, ethylene, hexane, and isobutylene. The accident apparently occurred when operators were trying to remove solidified polyethylene from the system. The vapor cloud (estimated to be roughly 1100 feet long, 800 feet wide, and 5 feet high) drifted downwind for about 90 to 120 seconds (another account said 5 minutes) before contacting an ignition source. The wind was from the south at 10 to 16 mph. The vapor cloud plus additional flammable gas inside tanks at the valve source exploded with a force equivalent to 2.4 tons of TNT based on blast damage. Two isobutene storage tanks exploded 10 to 15 minutes later. A third explosion occurred 15 to 30 minutes later when a polyethylene plant reactor failed catastrophically. The two polyethylene production plants covering 16 acres near the source of the blast were destroyed. Windows were shattered and bricks were ripped out in an administration building 0.5 miles away. Fragments were thrown as far as six miles away. The OSHA investigation uncovered a number of deficiencies resulting in fines against the petrochemical company and its operating contractor.

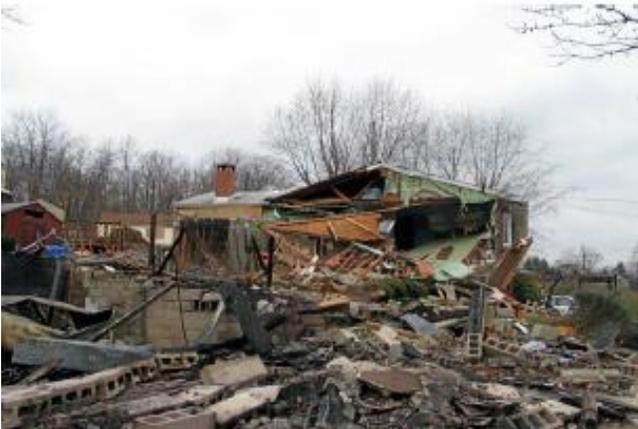
From National Transportation Safety Board Report DCA-08-FP-006

The cause of the explosion was a corroded and cracked 2-inch natural gas pipeline, at 10 psig, which failed resulting in natural gas entering the home via a porous backfill for a nearby sewer line from the house. All this occurred underground with no advanced warning. Apparently the home filled quickly with natural gas as no one in the neighborhood noticed the natural gas odorant. The concentration of natural gas reached the lower explosive limit, the gas found an ignition source, and the house exploded.

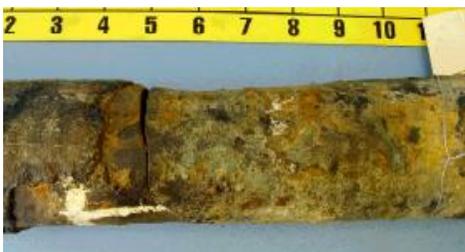
Cracked natural gas pipeline feeding house

The report concluded excavation 5 years earlier for a sewer line likely damaged the protective coating of the pipeline allowing corrosion and eventual pipe failure to occur. The pipeline itself was not affected by the house explosion.

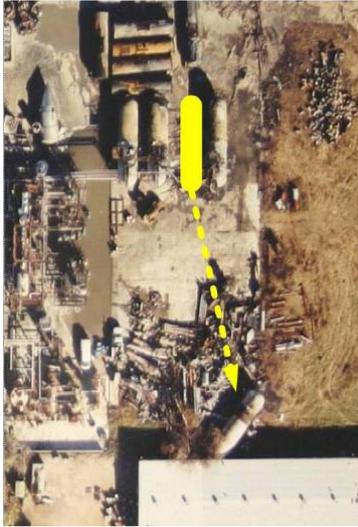
On 3 December 2004, a tank flash fire and explosion occurred at a processing facility operated by Marcus Oil and Chemical on the southwest side of Houston. The horizontal tank itself (12 foot in diameter and 50 foot long) was propelled 150 feet where it impacted a warehouse (see yellow arrow at left). The tank was part of a polyethylene wax processing operation, and normally operated at 300°F and under a mostly nitrogen atmosphere at about 45 psig. Later investigation by the U.S. Chemical Safety Board (CSB) showed that that tank likely failed due to a defective weld at a tank patch plate at possibly 69 psig, and that the nitrogen generator used to pressurize the system contained as much as 18% oxygen. A fire resulted which burned for 7 hours. The blast caused structural damage and glass breakage up to 0.25 miles away. A 120 pound steel plate was found in a pasture 900 feet away. A 2-pound steel plate was found in the yard of a resident ¼ mile away. The full report is available at

Normally, the wax-like material inside the tank was not considered flammable but is combustible. The CBS report concluded that at about 69 psig, the defective weld failed severing a tank patch plate from the tank. When the patch plate struck the concrete pad, sparks were generated which ignited the wax and hydrocarbon vapors coming from the tank. The flame flashed back into the tank. An internal deflagration blew the vessel head into multiple fragments.

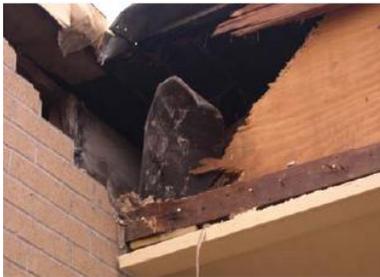
20-lb tank fragment embedded in a wall 300 feet from company property line

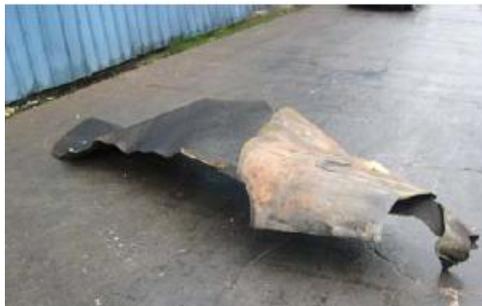
750-lb tank fragment landed near employees (both photos from CSB report)

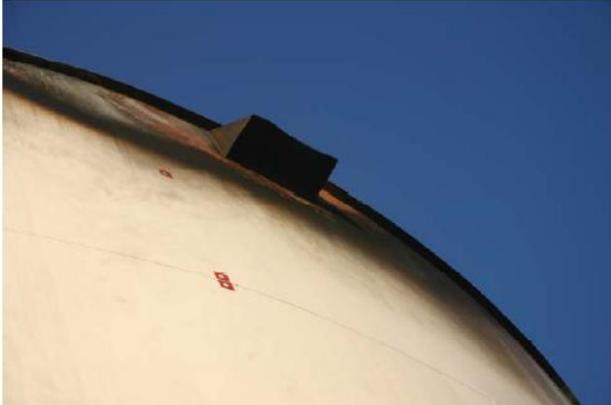
On 12 January 2009, at the Silver Eagle Refinery, Woods Cross, Utah, flammable vapors were released from the tank vent at left while the tank was being filled with light naphtha under atmospheric pressure. The resulting vapor cloud found an ignition source, resulting in an ensuing flash fire 230 feet long. Two refinery operators and two contractors suffered serious burns. The tank contents, which contained an estimated 440,000 gallons of naphtha, did not catch fire.

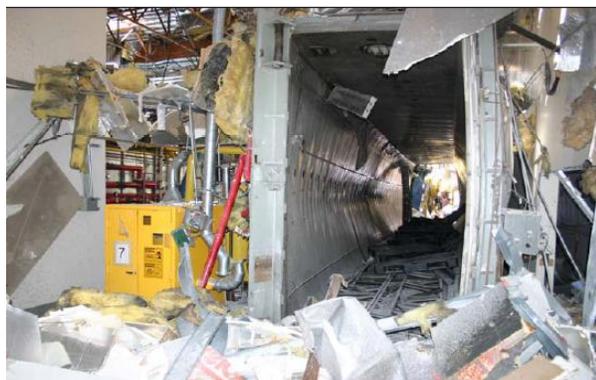
However, on the day of the explosion, during a system troubleshooting checkout with no medical products in the chamber, operators bypassed some of the flushing steps to save time (a bad decision). Furthermore, chamber had no monitoring or detection equipment to warn operators that an explosive mixture of ethylene oxide remained in the chamber when the chamber door was opened. This caused an estimated 50 lbs of ethylene oxide to vent to the catalytic oxidizer and also into the building setting off nearby LEL alarms. The ethylene oxide ignited in the catalytic oxidizer causing the flame to flash back to the chamber resulting in a powerful explosion. Fortunately, there were no employees in the chamber area at the time of the explosion.

Sterilization chamber, after explosion

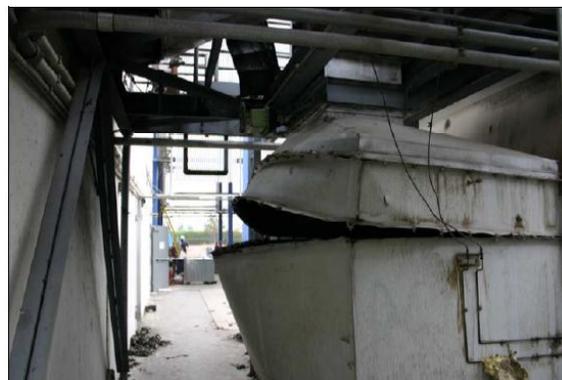
Catalytic oxidizer, after explosion

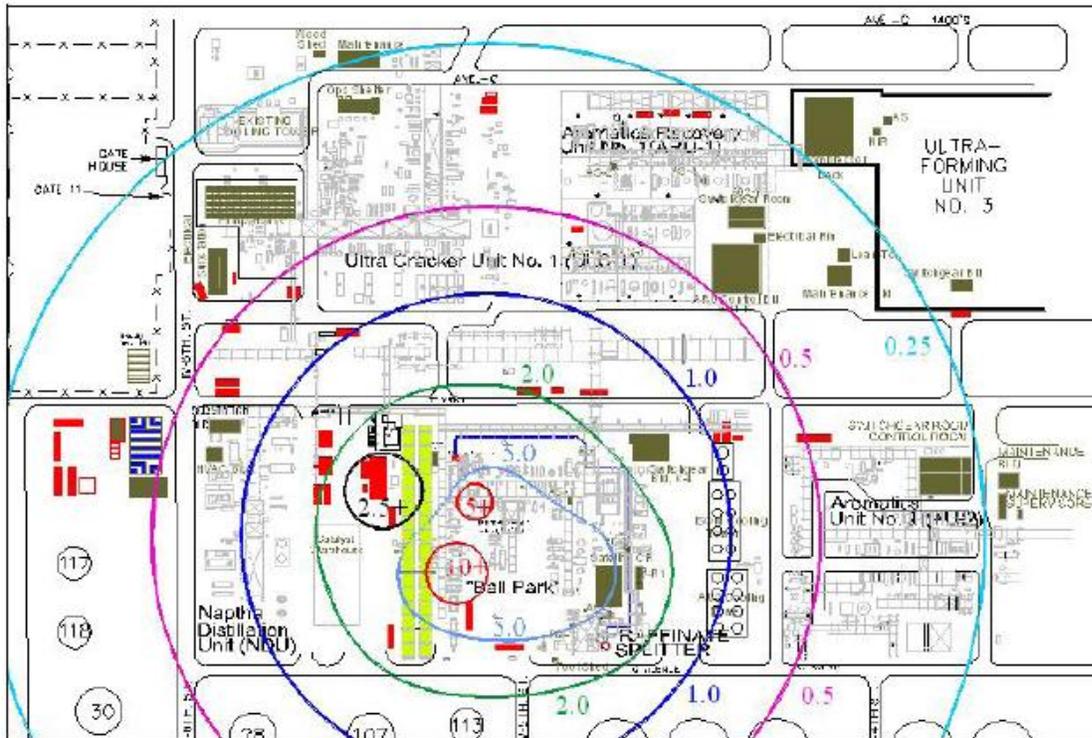
Blast overpressure map, based on site observations, structural analysis, and blast modeling. Over pressure circles at 10+, 5+, and 2.5+ psi; also 2.0, 1.0 (320 feet from center) 0.5 (540 feet), and 0.25 psi (940 feet). The 0.1 psi overpressure line (not shown) occurred at about 2000 ft. from the center, consistent with observations of furthest identifiable glass damage. Unfortunately, the CSB did not provide a scale for the map so these are our estimates based on text statements in the report.

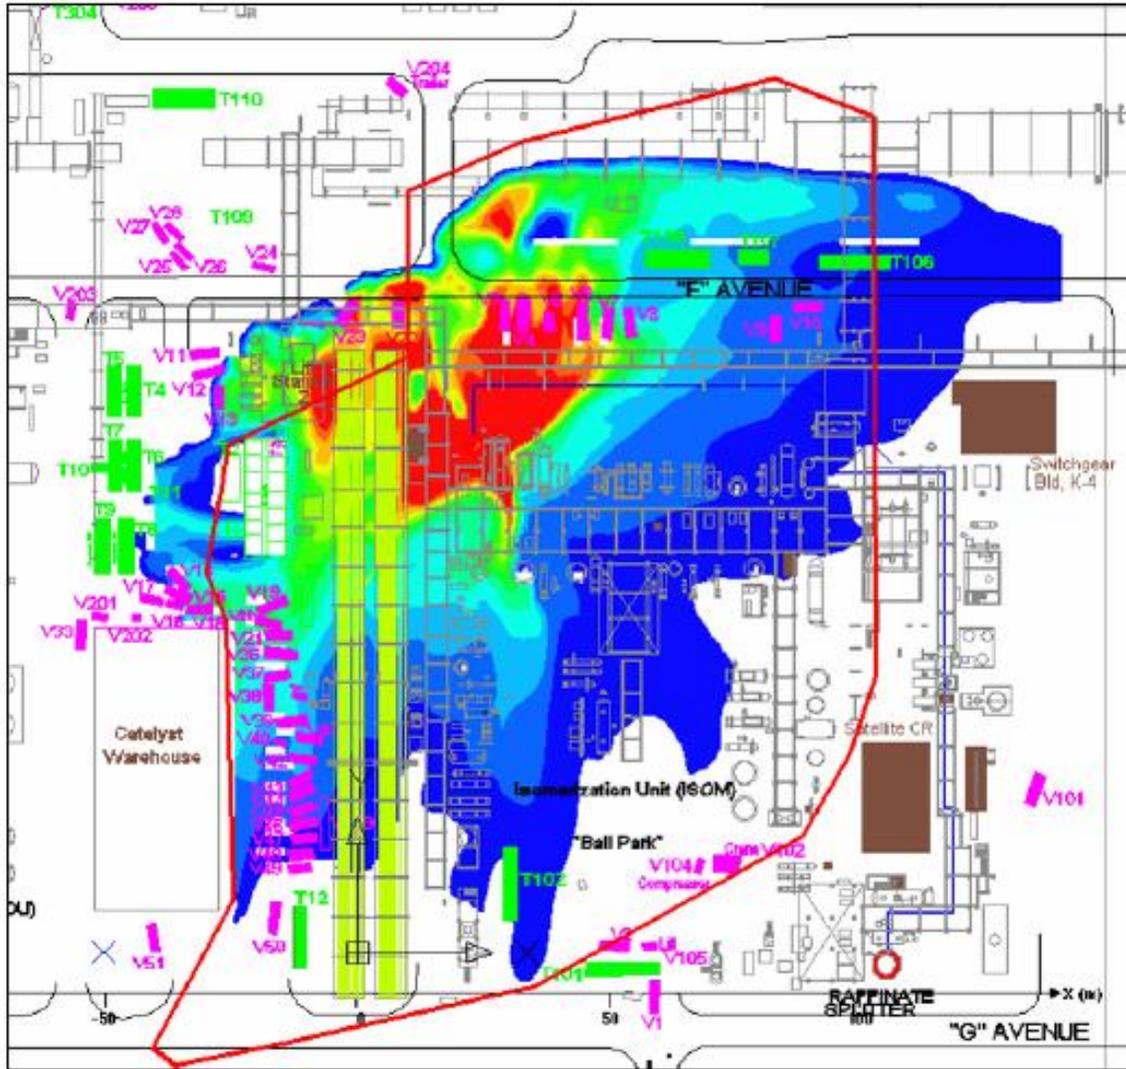
Estimated Vapor Cloud location. Field observations (red line), dispersion modeling (solid colors). From CSB report. Unfortunately, the CSB did not provide a distance scale for the sketch.

The CSB report estimated that as much as 6730 gallons of hydrocarbons was released to the outside as a vapor cloud and liquid which pooled before the explosion and additional 855 gallons after the explosion. The hydrocarbon mixture was 30.7% n-heptane, 29.5% iso-hexane, 15.2% n-hexane, 13% n-octane, 4.1% n-nonane, 1.4% n-decane, 3.8% n-pentane, and 2.6% iso-pentane. The CSB modeled the vapor cloud using a class A stability and 80°F temperature. Based on explosion damage distance observations, our modeling using the PEAC tool suggested that considerably less than 6730 gallons participated in the explosion based on a TNT yield factor of 0.03; the rest formed a liquid pool and a vapor flash fire (deflagration). The liquid pool was noted in the CSB report, which estimated the pool radius increased to 27 meters at 106 seconds after the release, the time of the blast. The burned area was 200,000 square feet.

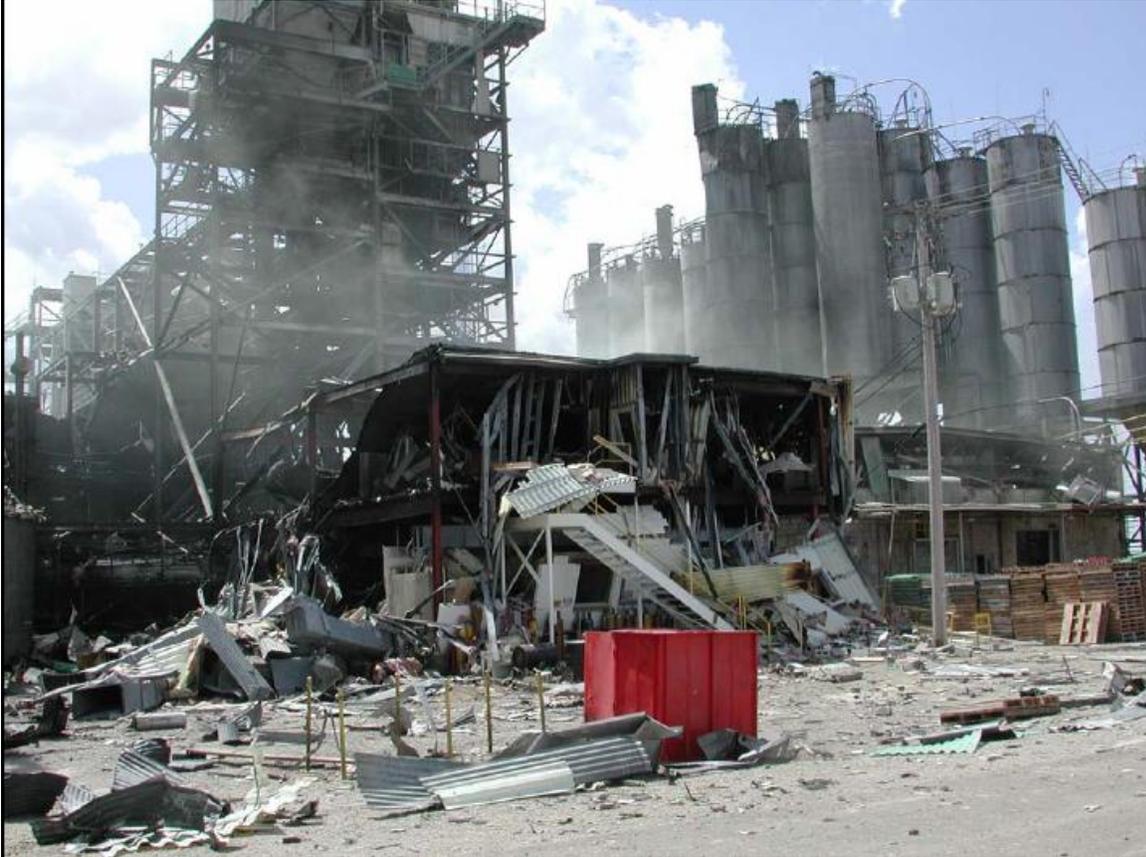
On 23 April 2004, an explosion and fire occurred at a polyvinyl chloride (PCV) manufacturing facility killing five and injuring three employees. The resulting fire spread to PVC resins stored in a nearby warehouse, resulting in smoke drifting over the nearby community of Illioopolis, Illinois. The community within one mile of the site evacuated for two days. The facility was shut down and not rebuilt.

Vinyl chloride monomer is used in the manufacture of PCV. The chemical has a boiling point of 7°F (-14°C), a lower explosive limit of 3.6%, toxic (OSHA 8-hr permissible exposure limit of 1 ppm, and a potential occupational carcinogen. The CSB report determined that the explosion occurred when an operator drained a full and pressurized PVC reactor. Another operator cleaning a nearby reactor apparently opened the bottom valve of an operating releasing approximately 15000 lbs vinyl chloride monomer, PVC, and other ingredients. The two operators and the shift supervisor attempted to manage the release and did not evacuate and subsequently died when the released vinyl chloride contacted an ignition source. Two other workers were also killed, including one who died in the hospital two weeks later.

The root cause was confusion on the part of an operator or operators as to which valve to open, and that the interlock protection for the bottom valve had been bypassed. The company had an emergency transfer procedure to transfer reactor contents to another reactor in case of excessive pressure buildup in a reactor which required them to open the bottom valves and transfer valves to connect the reactor to another reactor, but the tank contents were released to the room. According to accounts, there were several explosions as the fire contacted other tanks.

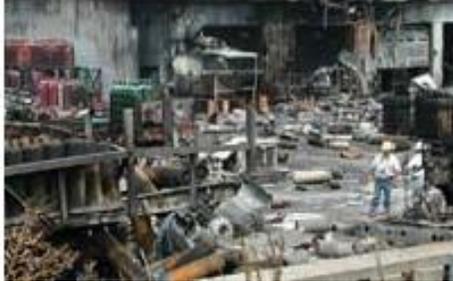
At left is the facility after fire engulfed thousands of cylinders of propylene, propane, acetylene, and other flammable gases. During the fire, exploding gas cylinders or cylinder parts were launched into the community.

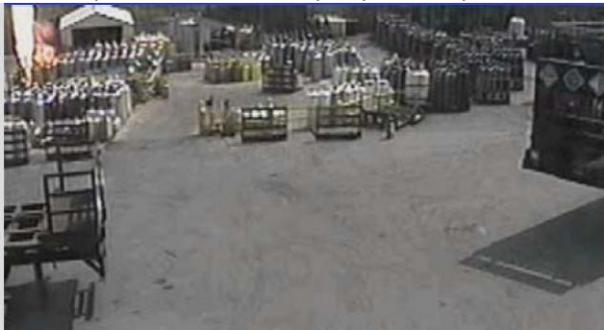
Security camera view, One cylinder catches fire (upper left), 3:20 PM, the start of the incident.

According to the CSB Safety Bulletin (available at CSB website), the likely root cause was a combination of hot ambient temperature and direct sunlight heating which caused one of the partially-filled propylene cylinder internal pressure to build up. The safety release valve on the cylinder opened and vented the propylene. The vented propylene gas found an ignition source (probably static electricity) and caught fire. The fire heated an adjacent cylinder causing it to vent propylene which also caught fire. A domino effect occurred, eventually affecting about 8000 cylinders. The safety release valve on the initial cylinder may have been set to vent at too low a pressure as the gas cylinders were designed to withstand much greater pressures than what would normally be produced in a cylinder sitting in the hot sun. The normal minimum relief setpoint for propylene cylinders is 390 psig, which corresponds to a temperature of 149°F. On a very hot day with cylinders sitting out in the sun, temperatures could exceed maybe 130 or 140°F, which could result in venting if the relief setpoint is too low.

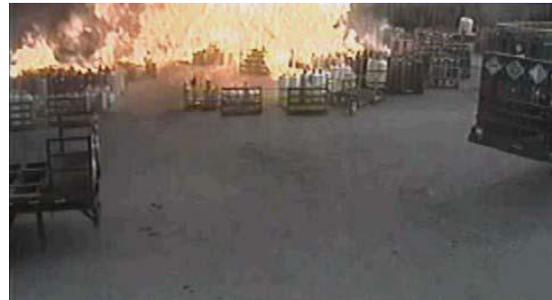
Security camera, fire spreads after three minutes; cylinders are starting rocket at two minutes

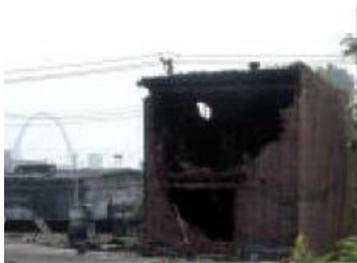
Burned out vacant commercial building, 300 feet away, from rocketing burning fragments

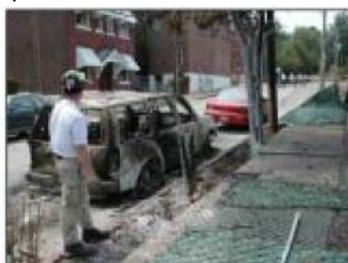
Burned out car, 200 feet away; several cars catch fire due to burning cylinder fragments

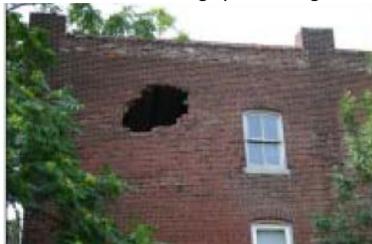
3-foot hole in side of residential building due to rocketing fragment, 530 feet away
