Real-World Explosions and Fire Examples

by Dr. John Nordin

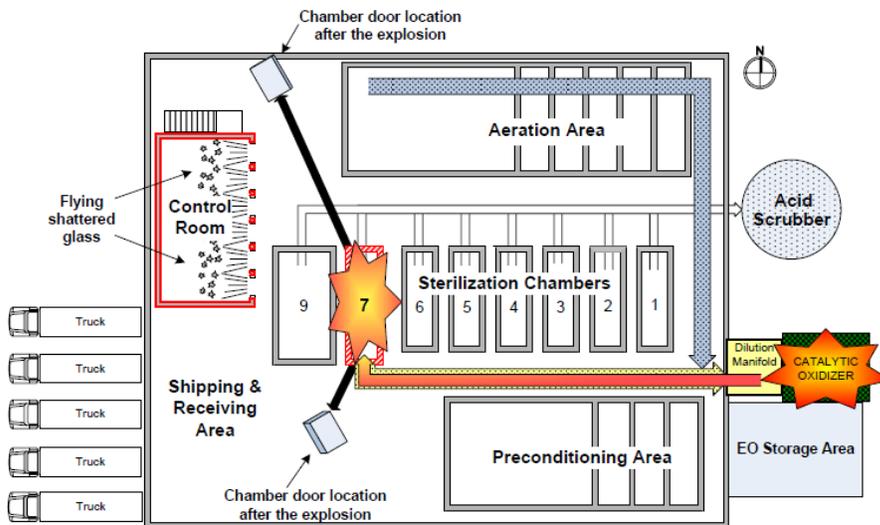
However, on the day of the explosion, during a system troubleshooting checkout with no medical products in the chamber, operators bypassed some of the flushing steps to save time (a bad decision). Furthermore, chamber had no monitoring or detection equipment to warn operators that an explosive mixture of ethylene oxide remained in the chamber when the chamber door was opened. This caused an estimated 50 lbs of ethylene oxide to vent to the catalytic oxidizer and also into the building setting off nearby LEL alarms. The ethylene oxide ignited in the catalytic oxidizer causing the flame to flash back to the chamber resulting in a powerful explosion. Fortunately, there were no employees in the chamber area at the time of the explosion.

Sterilization chamber, after explosion
